New Milbank Pedestal Replaces Corroded Equipment for Municipality

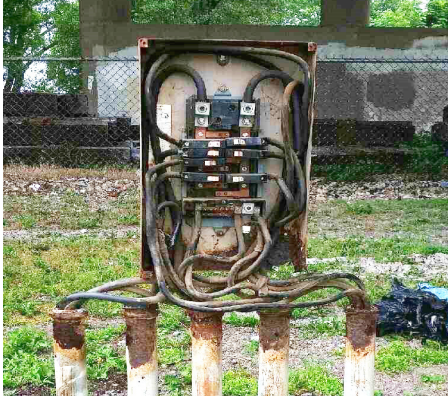
Rusted and outdated unit powering lighting on the Route 250 highway bridge in Sandusky, Ohio.

The Route 250 highway bridge in Sandusky, Ohio, had a corroded electrical supply enclosure powering its street lights. The old unit was rusted and falling apart, creating an unsafe area, and was not sustainable for the future. The unit contained a power-supply load center with interior conductor circuits that were too large to put in a standard breaker. The challenge was to create a more permanent solution that could continue to provide lighting for the bridge.

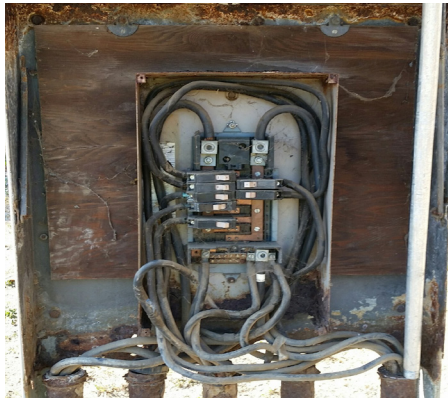
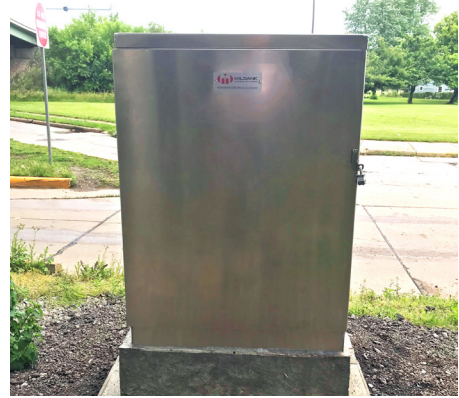
Newly installed unit powering lighting on the Route 250 highway bridge in Sandusky, Ohio.

Milbank engineers were able to replace the outdated, rusting unit with a more clean, safe and secure power source solution. The new aluminum enclosure contains a load center and is raised off the ground with a concrete base. The updated power source unit includes terminal blocks in order to accommodate larger conductors and has room to grow in the future with more components like additional circuits, photocell, Hand-Off-Auto switch and more.
